# SPARSHOLT

*by David Johnston*

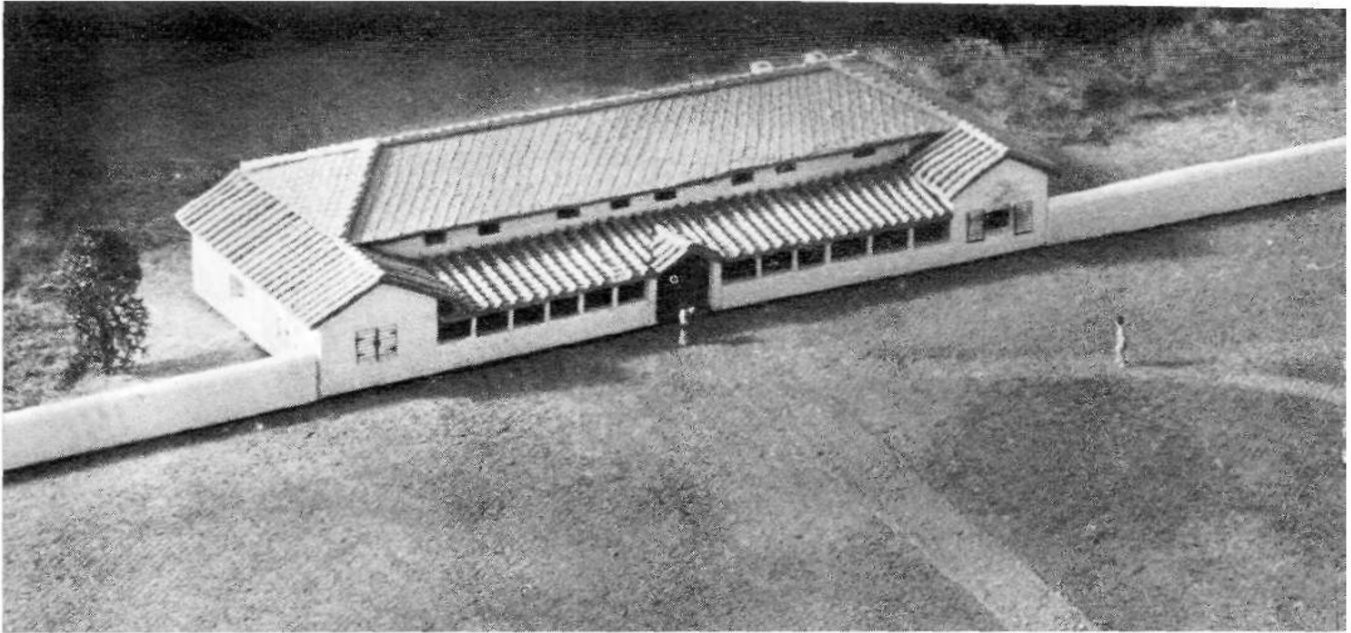
This reconstruction model of the Sparsholt Roman villa shows how the villa must have looked in its hey-day. The house (above) is a long narrow building with a verandah running along in front. The main farm building (opposite) had accommodation for farm workers at the top end, a set of baths at the bottom end, while the centre formed an open area for farm animals and equipment.
